PLANS FOR
IMPROVEMENT OF NAVIGATION CONDITIONS
IN
CORRAL BAY AND THE VALDIVIA RIVER, CHILE

HYDRAULIC MODEL INVESTIGATION

TECHNICAL MEMORANDUM NO. 2-382

WATERWAYS EXPERIMENT STATION
VICKSBURG, MISSISSIPPI

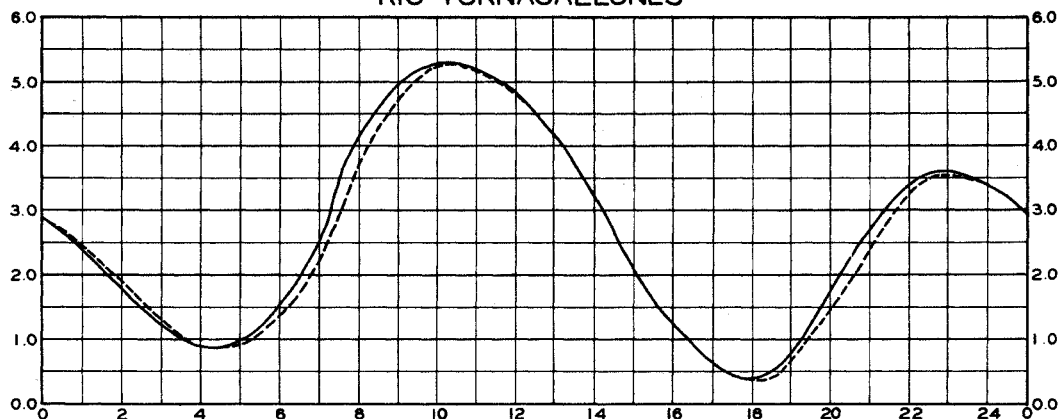
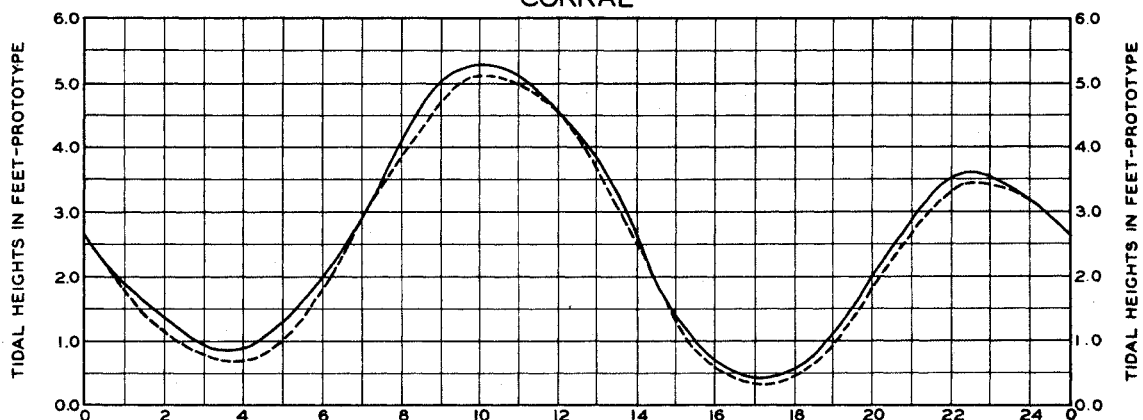
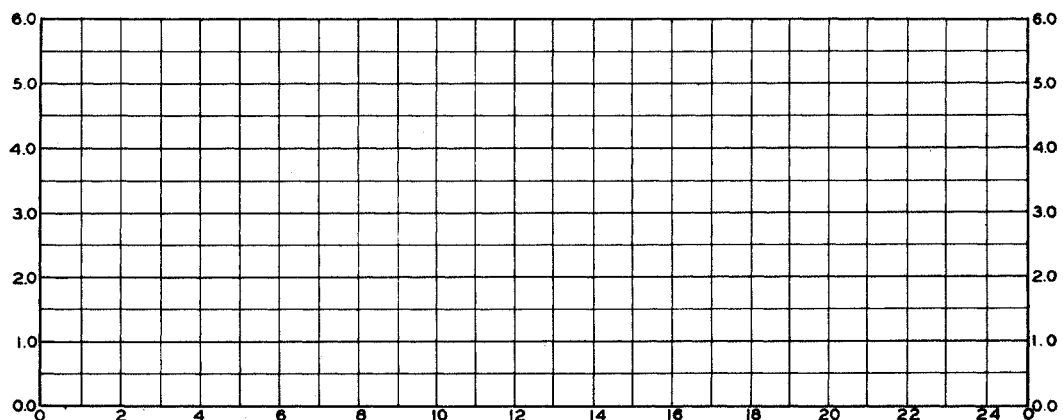
TIDE CURVES
PLAN 3
LOS MOLINOS, MUELLE DE PASAJEROS
AND CANCAQUAL

RIO TORNAGALEONES

CORRAL

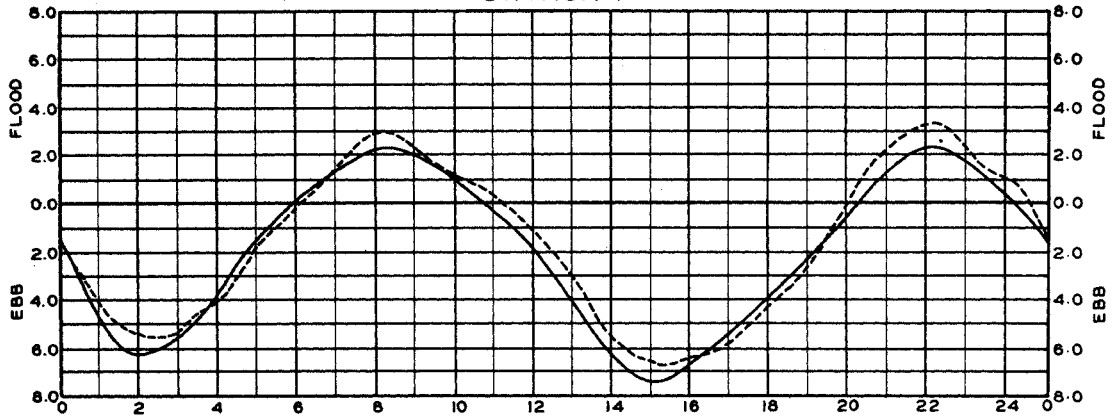
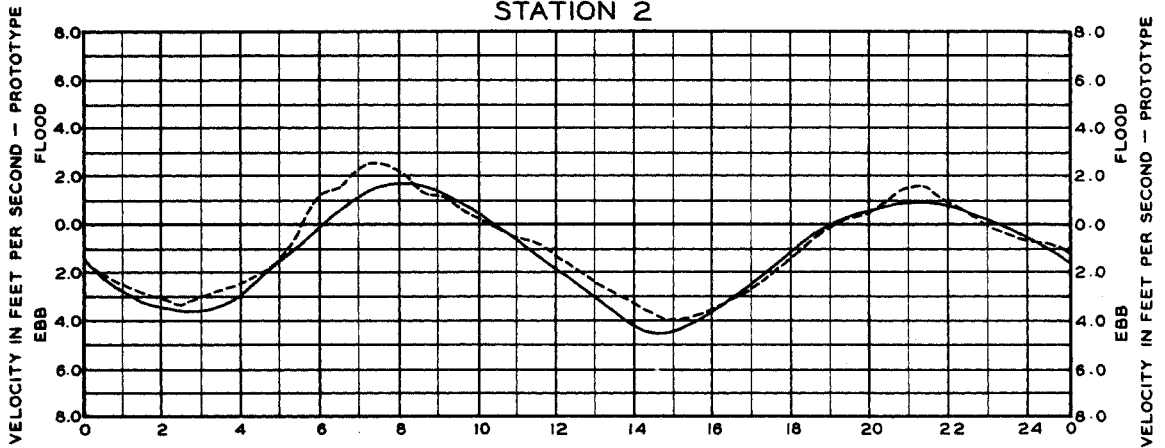
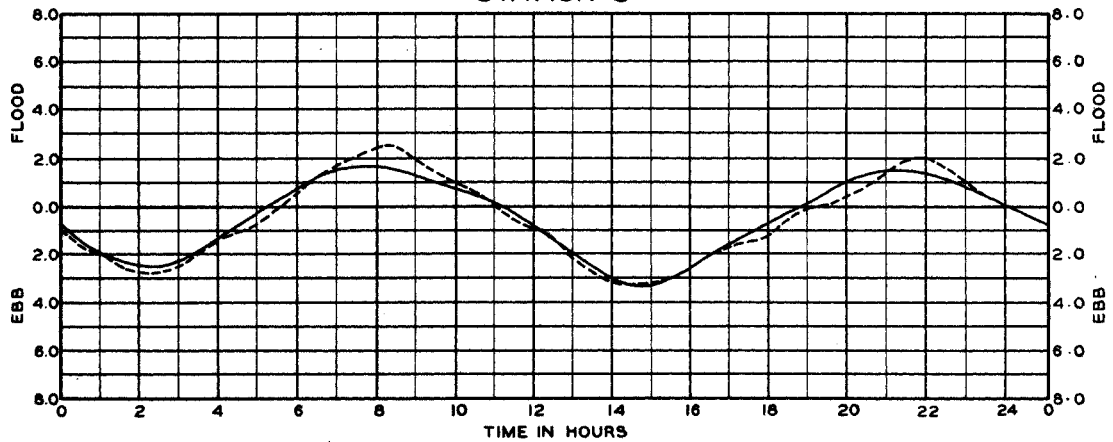
VELOCITY CURVES PLAN 3 STATIONS 1 TO 3

RIO TORNAGALEONES AND CORRAL

STATION 1

STATION 2

STATION 3

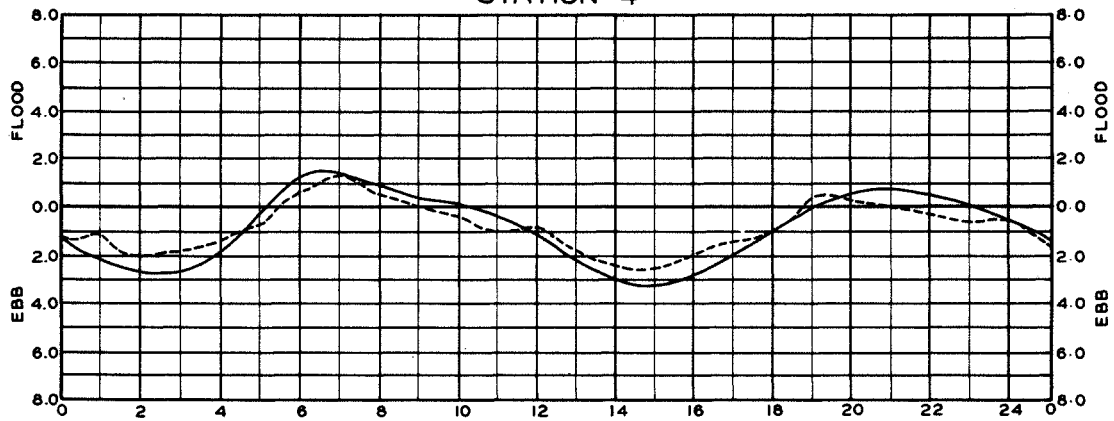
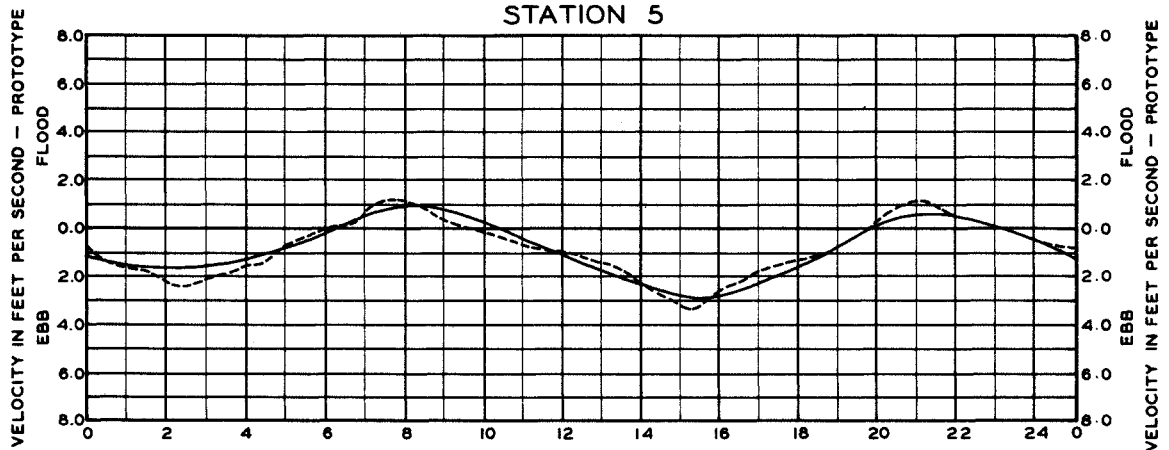
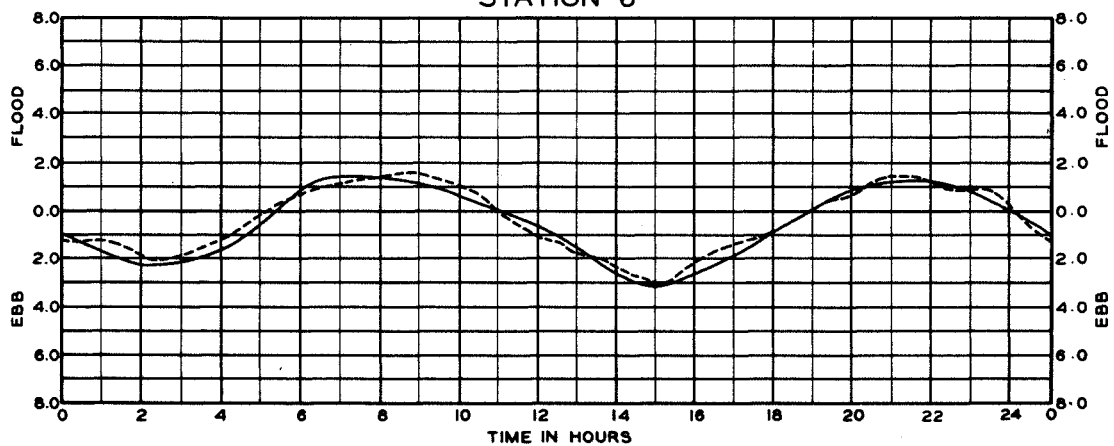
VELOCITY CURVES PLAN 3 STATIONS 4 TO 6

STATION 4

STATION 5

STATION 6

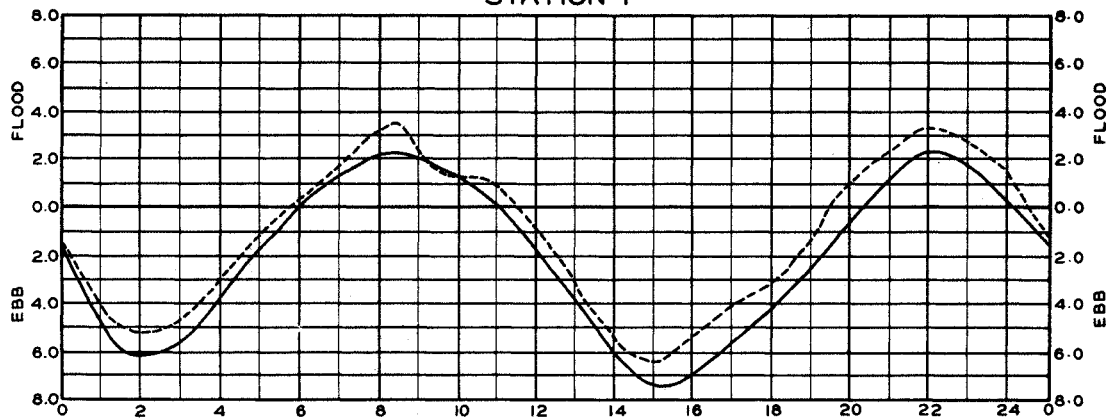
TIDE CURVES PLAN 4

RIO TORNAGALEONES AND CORRAL

STATION 1

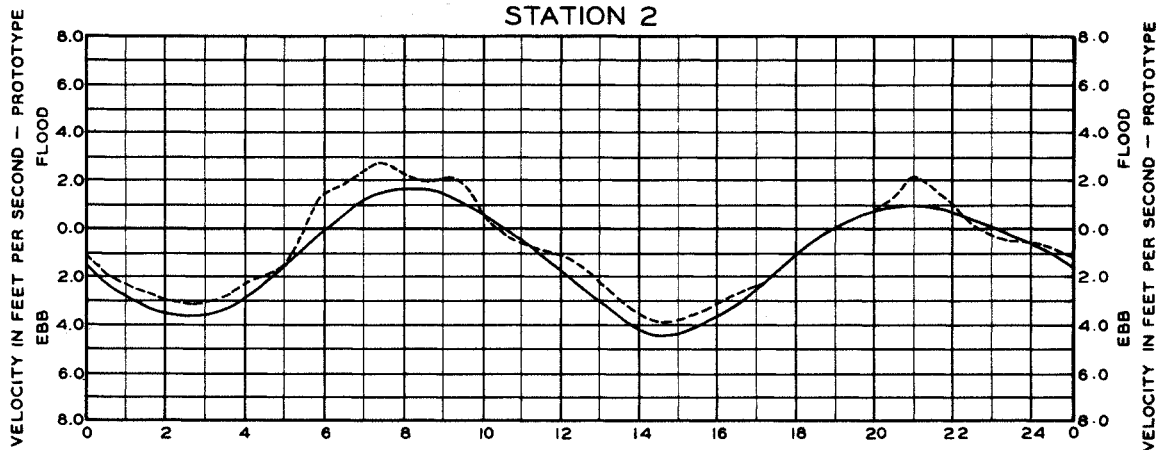
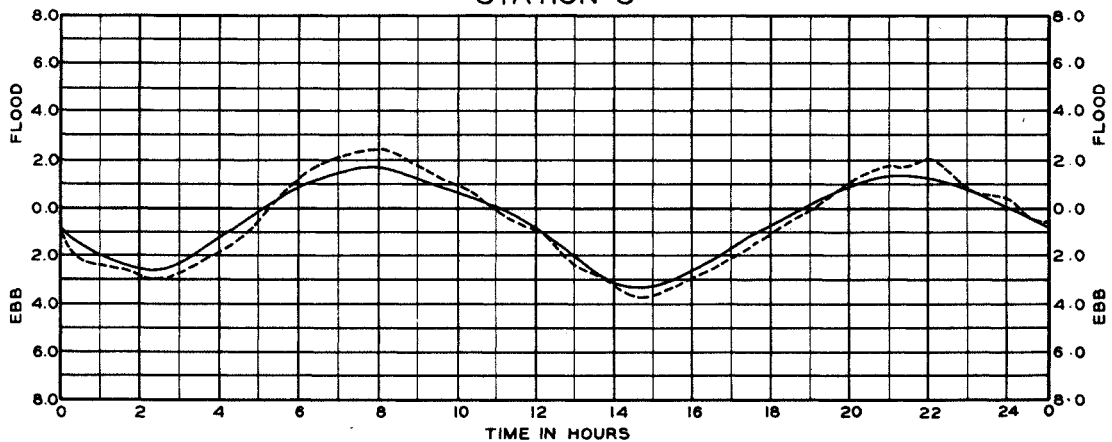
VELOCITY CURVES PLAN 4 STATIONS 1 TO 3

- BASE TEST VELOCITY CURVES
- PLAN VELOCITY CURVES

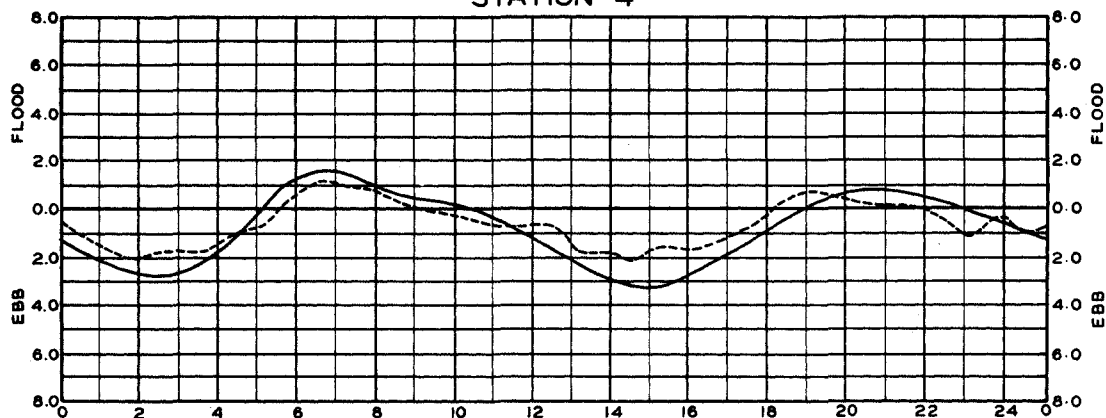
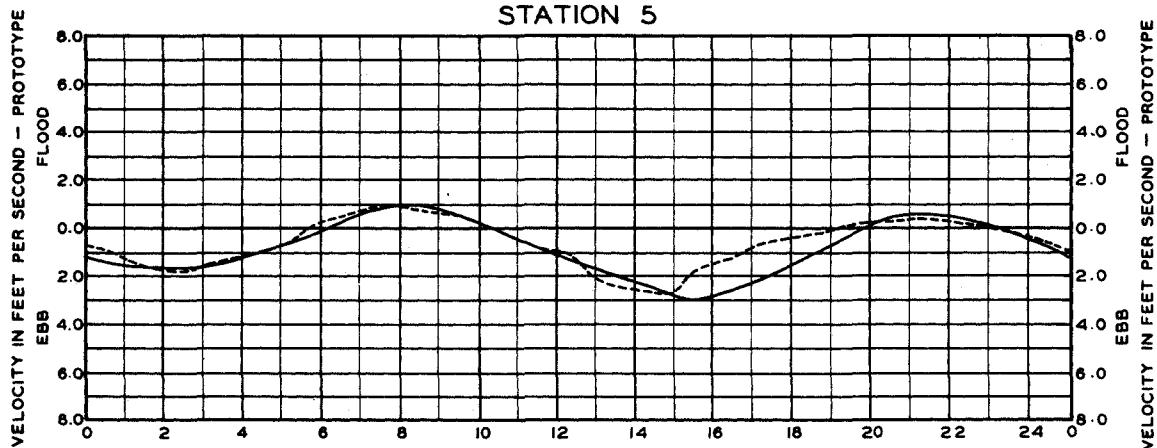
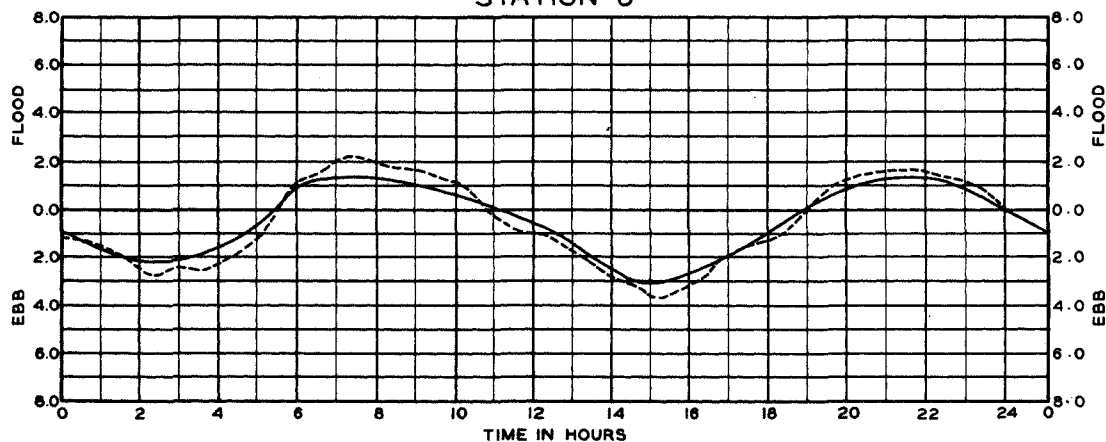
PLAN 4

- BASE TEST VELOCITY CURVES
- PLAN VELOCITY CURVES

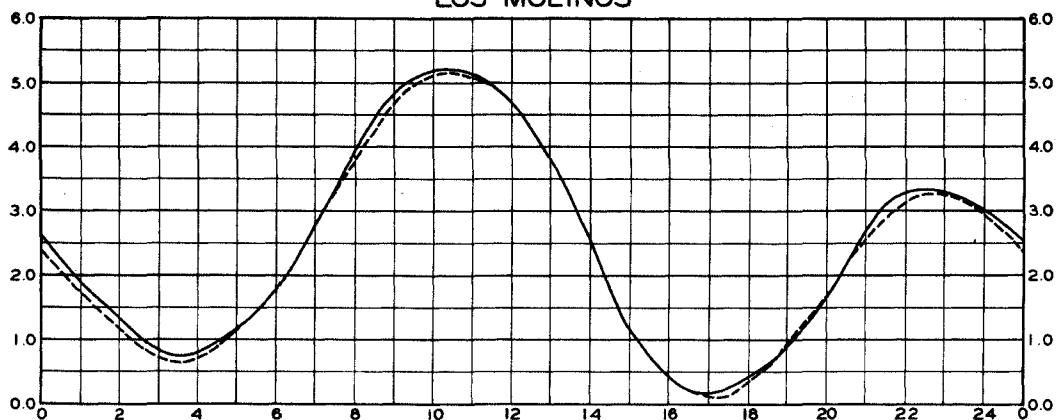
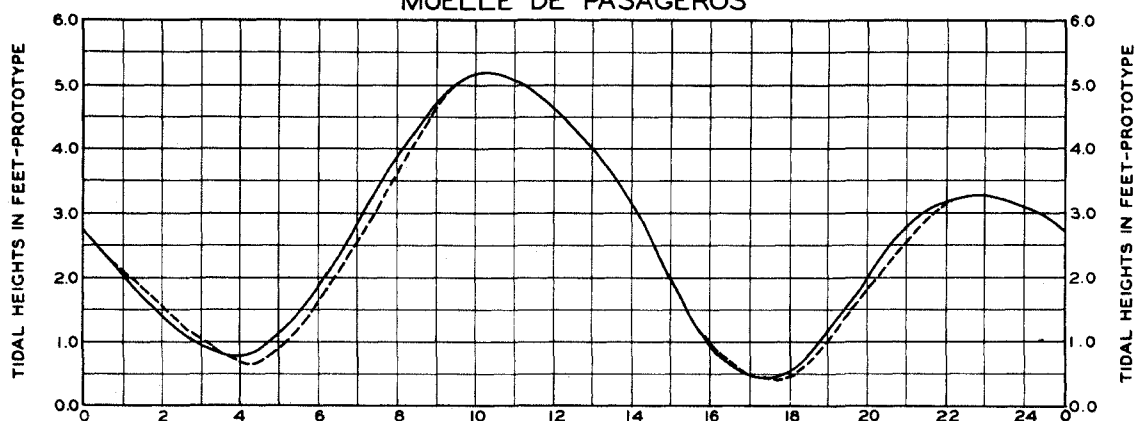
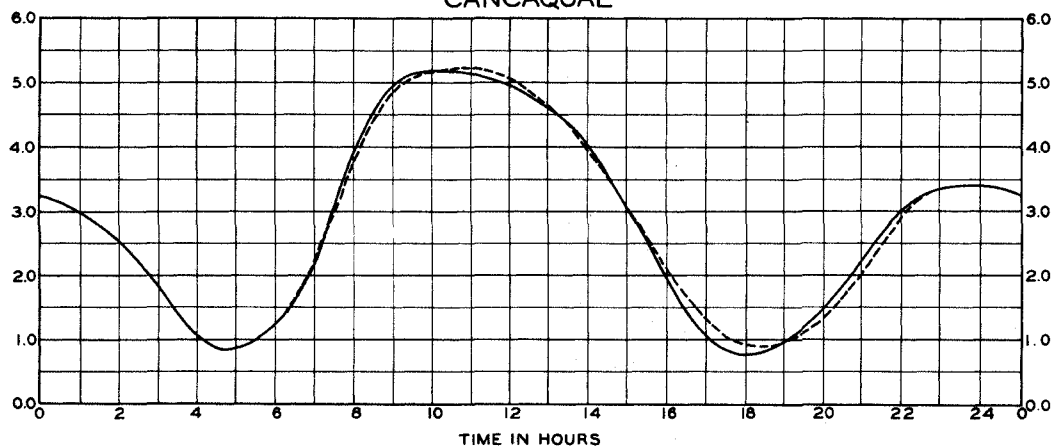
LOS MOLINOS, MUELLE DE PASAJEROS
AND CANCAQUAL

- BASE TEST TIDAL HEIGHTS
- PLAN TIDAL HEIGHTS

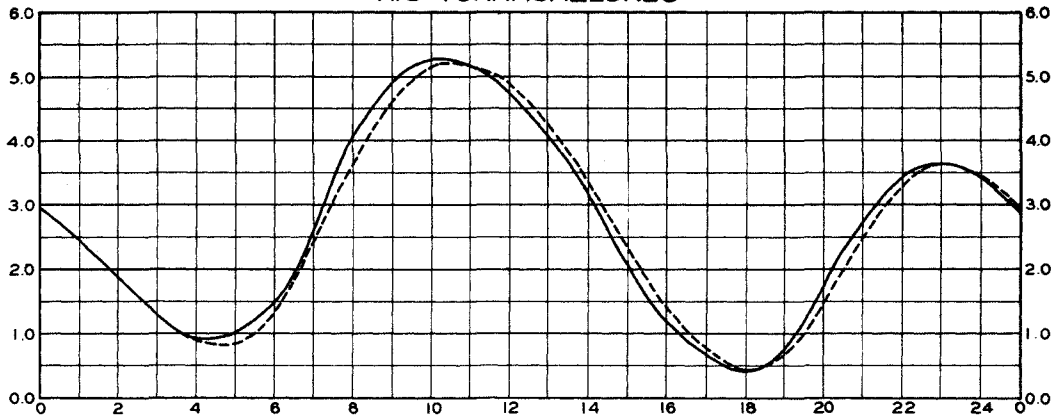
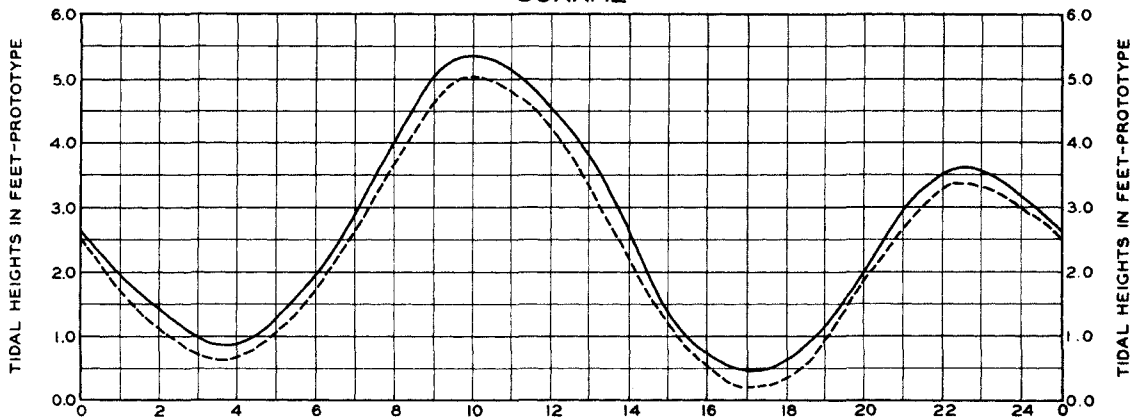
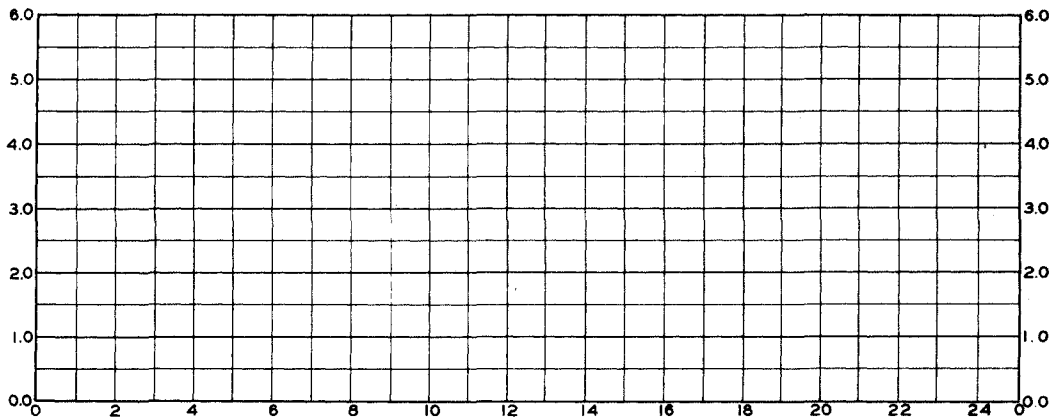
RIO TORNAGALEONES AND CORRAL

- BASE TEST TIDAL HEIGHTS
- - - PLAN TIDAL HEIGHTS

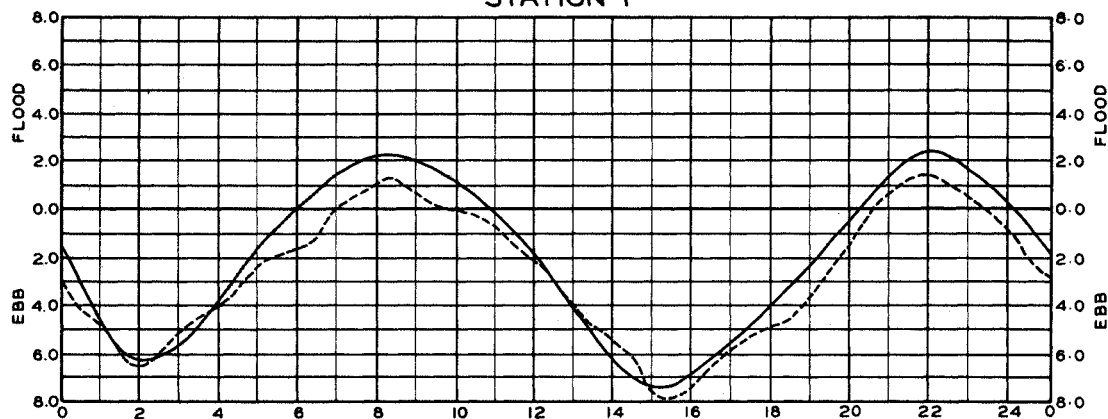
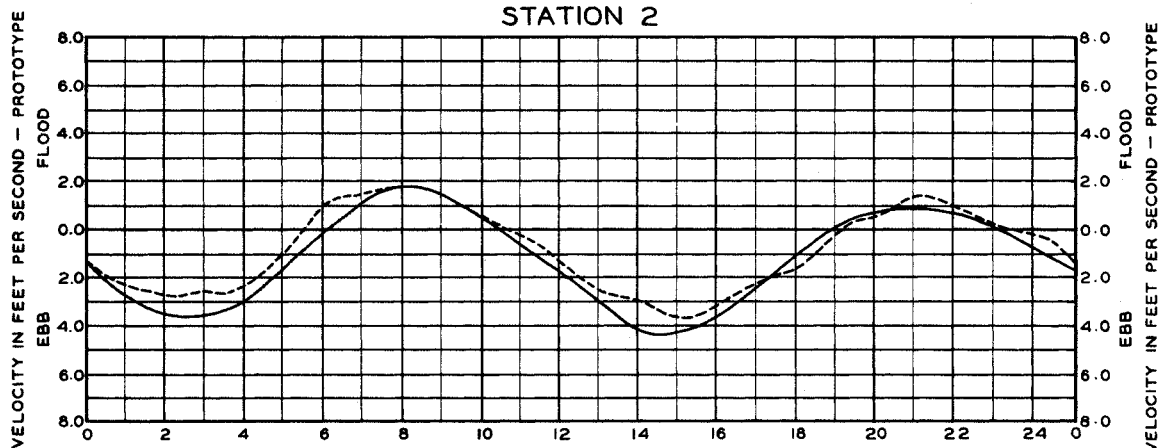
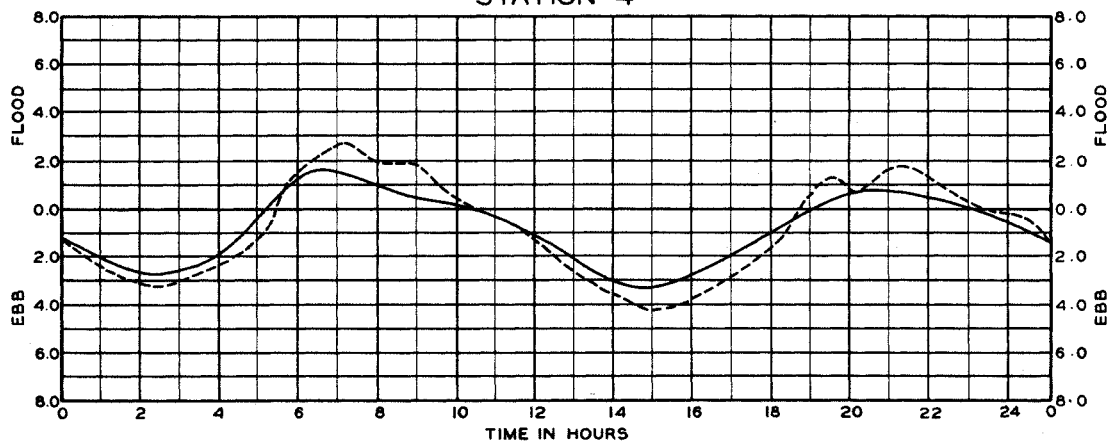
VELOCITY CURVES PLAN 5

- BASE TEST VELOCITY CURVES
- - - PLAN VELOCITY CURVES

NOTE: TIME IS EXPRESSED IN HOURS AFTER MOON'S
TRANSIT OF CORRAL MERIDIAN.

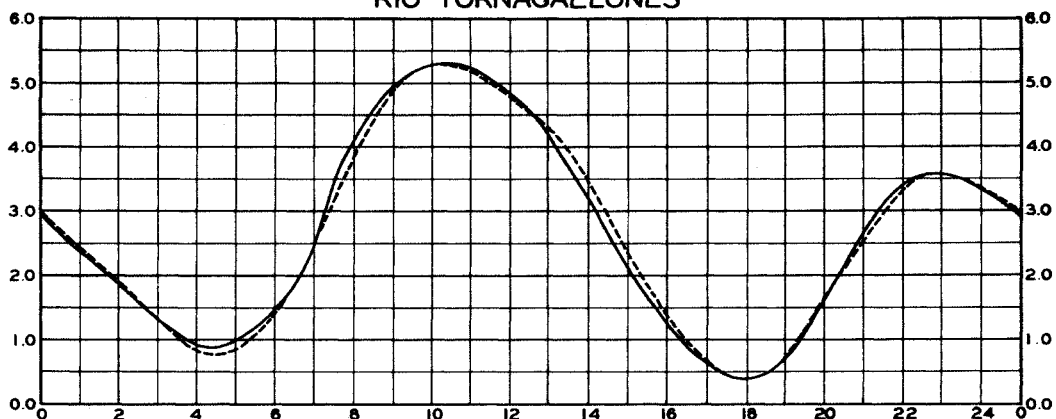
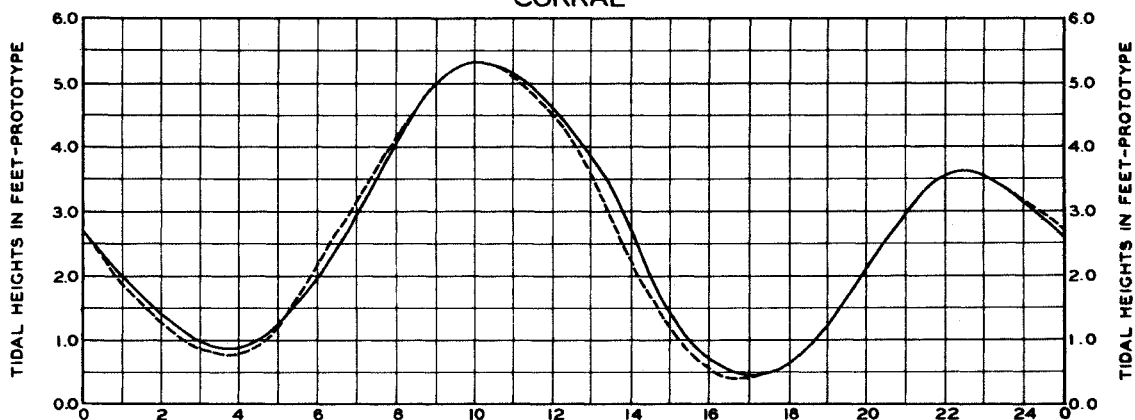
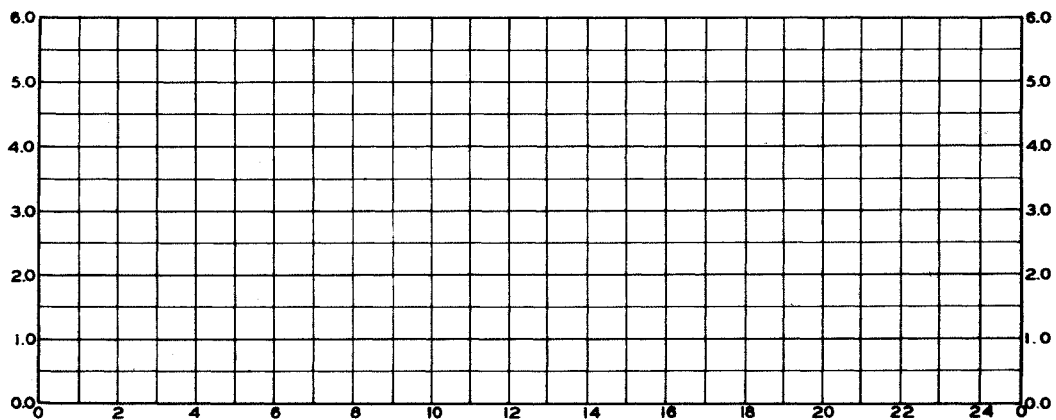
RIO TORNAGALEONES AND CORRAL

- BASE TEST TIDAL HEIGHTS
- - - PLAN TIDAL HEIGHTS

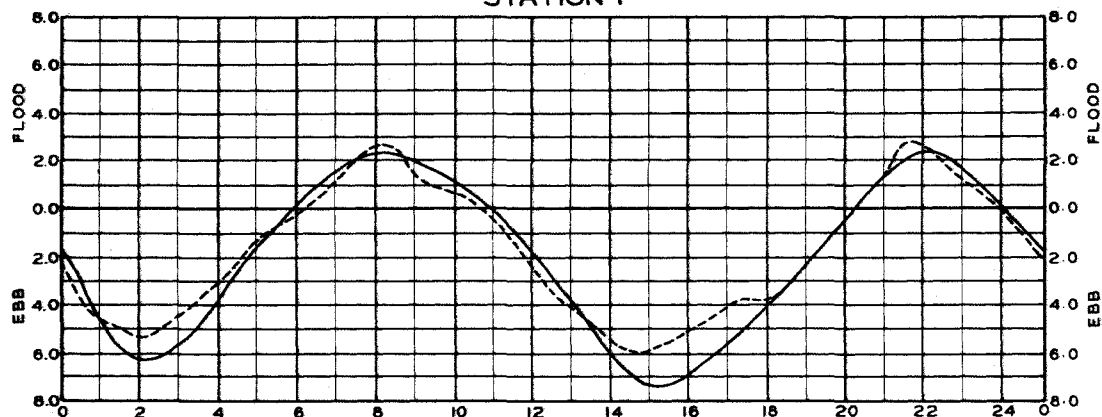
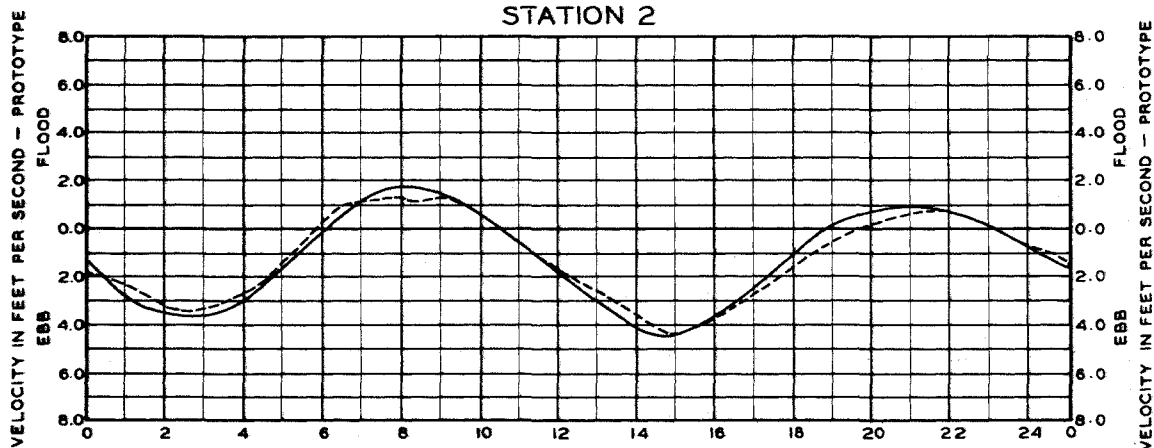
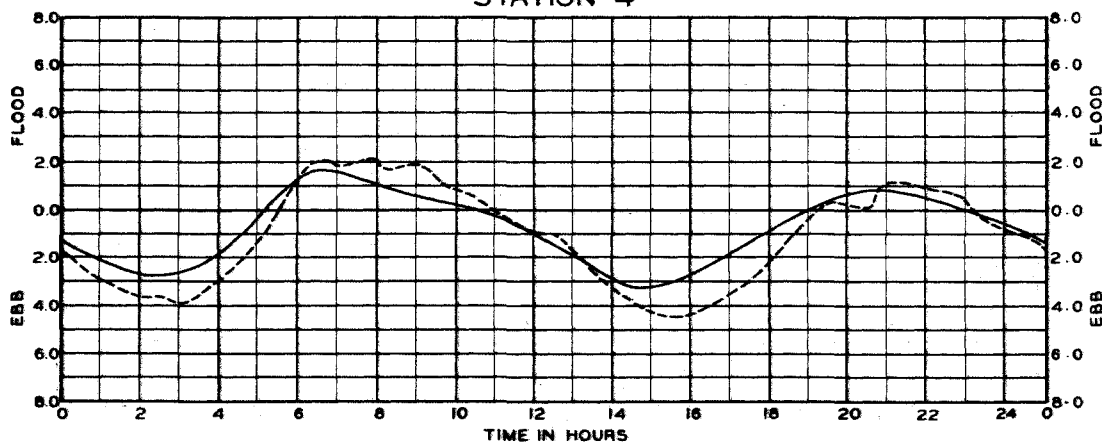
VELOCITY CURVES PLAN 6

- BASE TEST VELOCITY CURVES
- - - PLAN VELOCITY CURVES

NOTE: TIME IS EXPRESSED IN HOURS AFTER MOON'S TRANSIT OF CORRAL MERIDIAN.

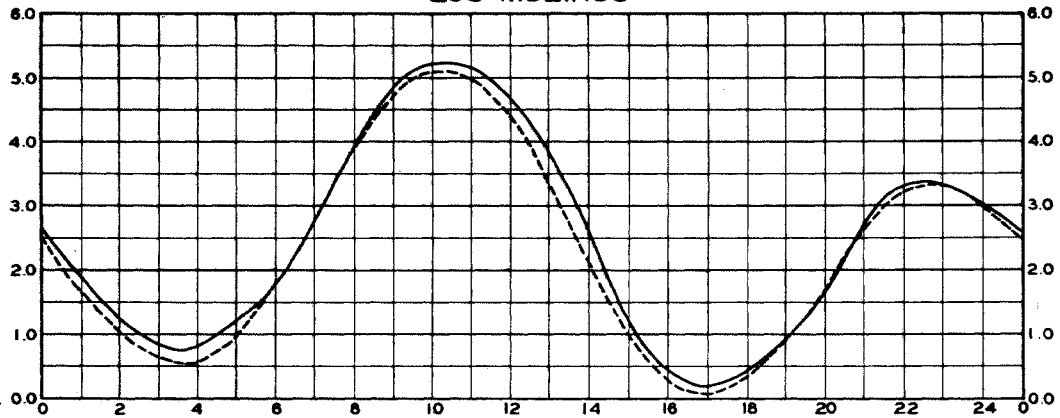
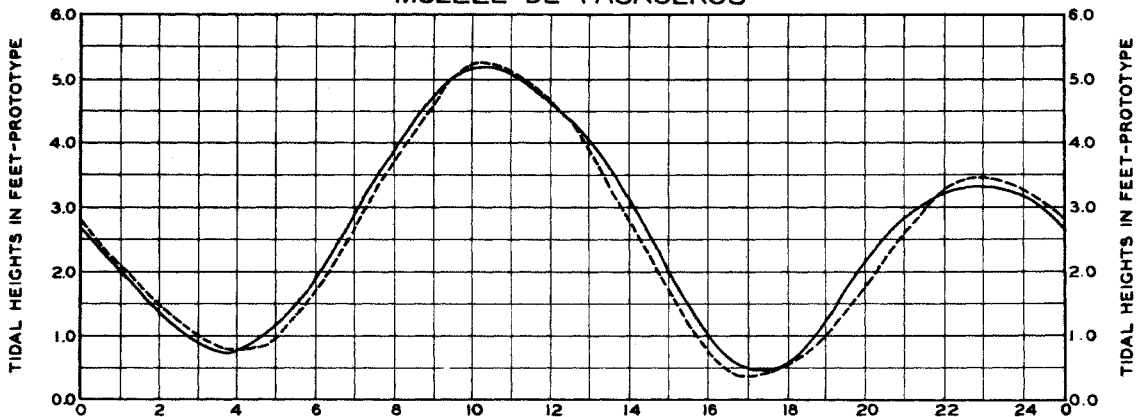
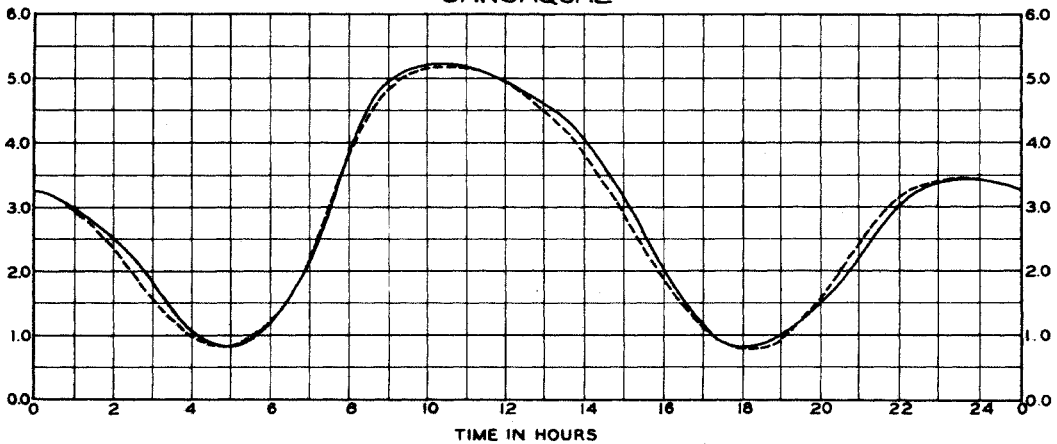
LOS MOLINOS, MUELLE DE PASAJEROS
AND CANCAQUAL

- BASE TEST TIDAL HEIGHTS
- - - PLAN TIDAL HEIGHTS

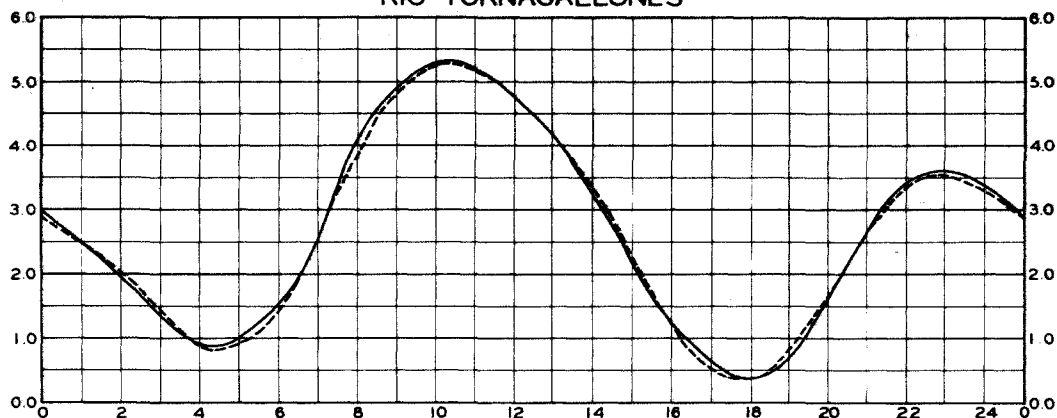
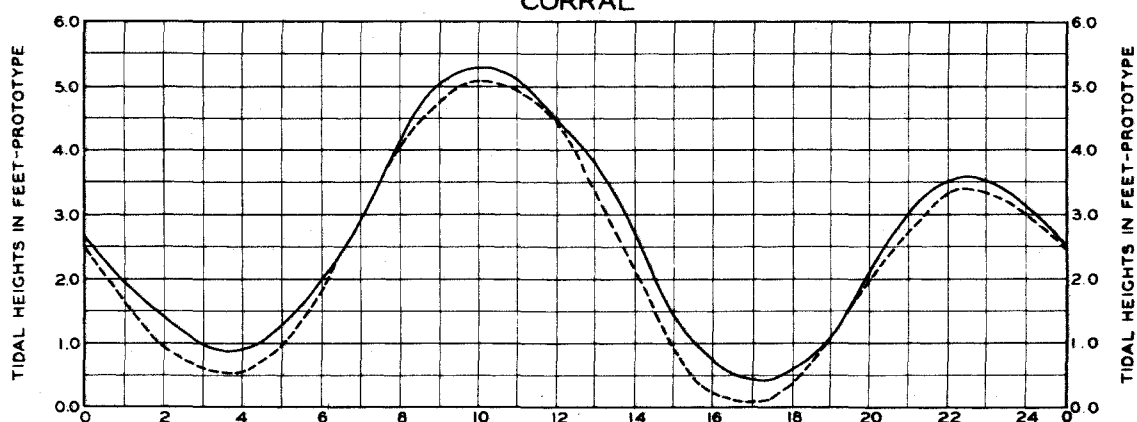
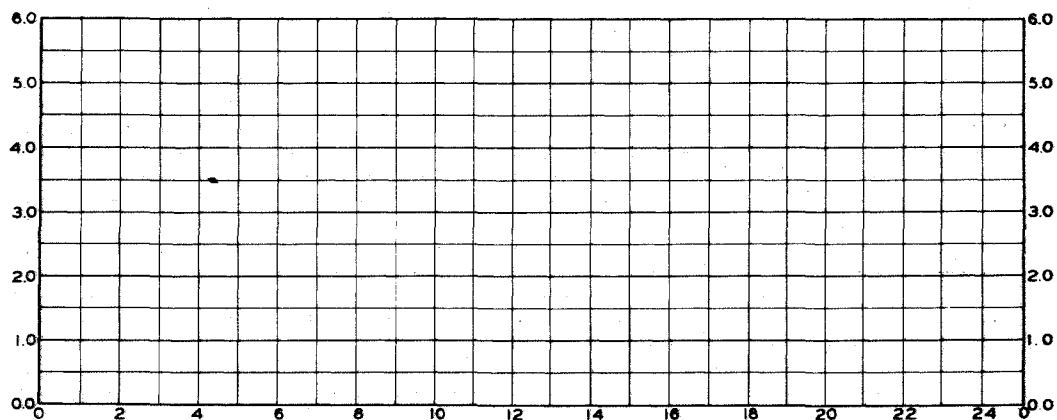
RIO TORNAGALEONES AND CORRAL

- BASE TEST TIDAL HEIGHTS
- - - PLAN TIDAL HEIGHTS

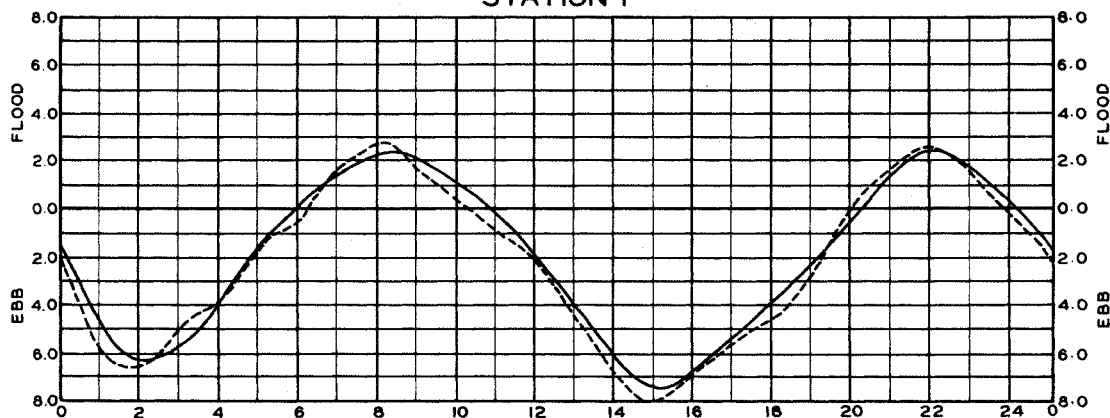
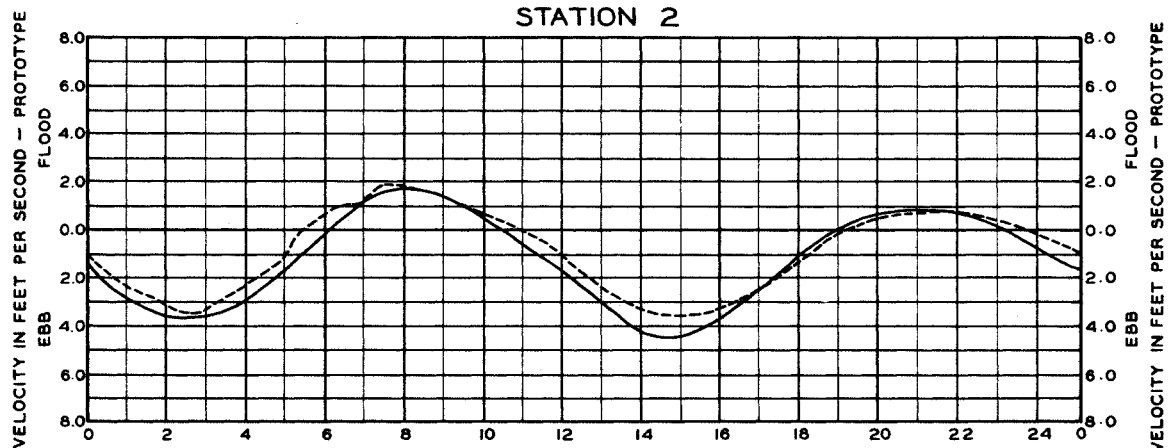
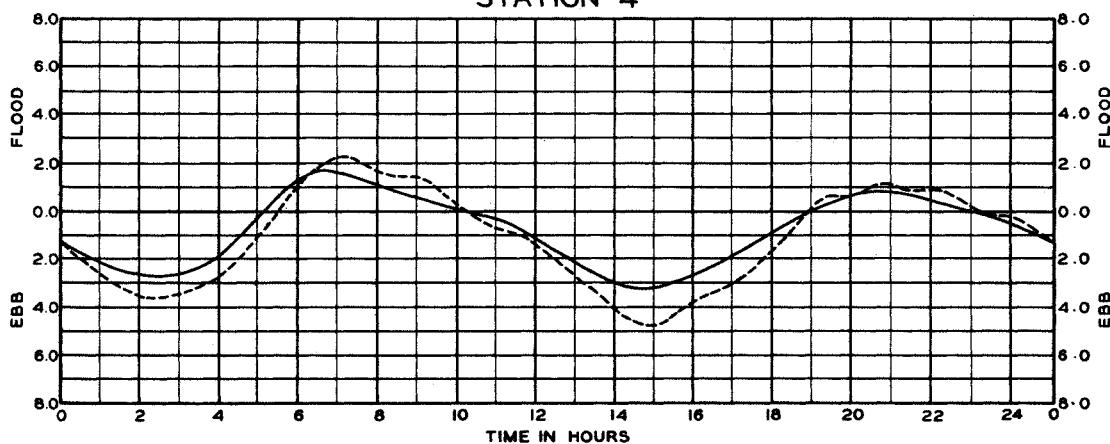
VELOCITY CURVES PLAN 7

- BASE TEST VELOCITY CURVES
- - - PLAN VELOCITY CURVES

NOTE: TIME IS EXPRESSED IN HOURS AFTER MOON'S
TRANSIT OF CORRAL MERIDIAN.
